## Project Understanding

## High School Pool Renovation

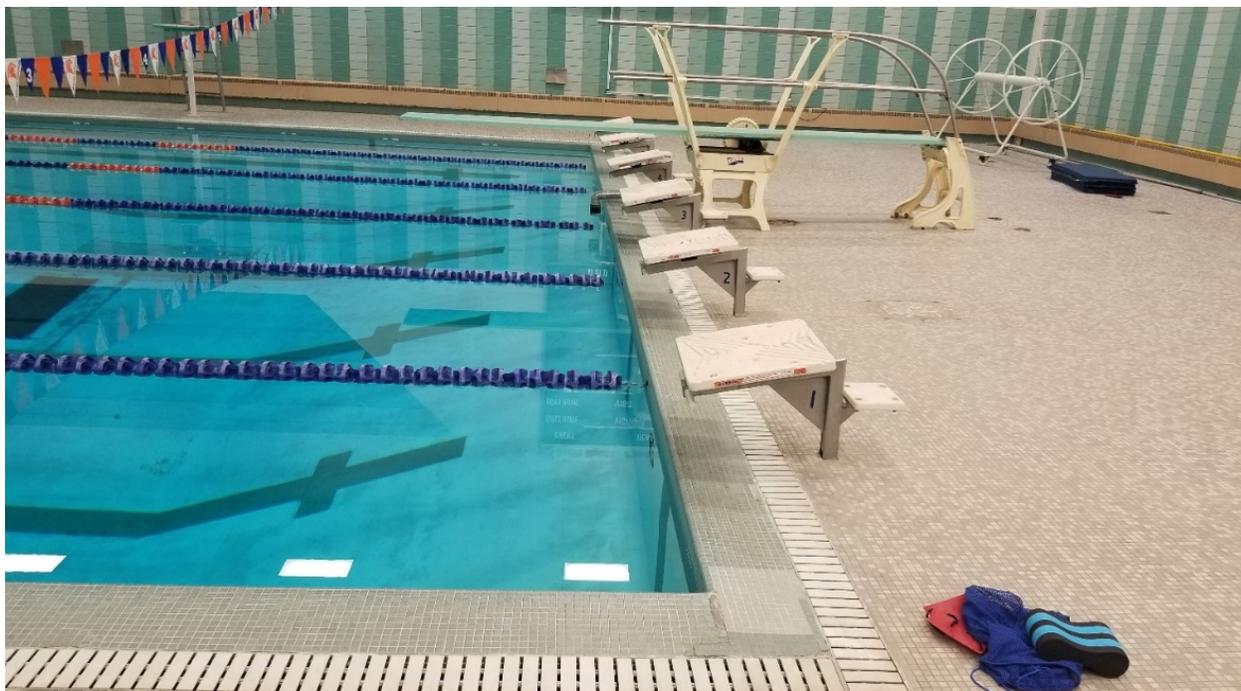
Water depth a plummet does not comply with Indiana Swimming Pool Code and NFHS. Solution is to remove the deep end and slopes adjusted bringing pool deep end into compliance

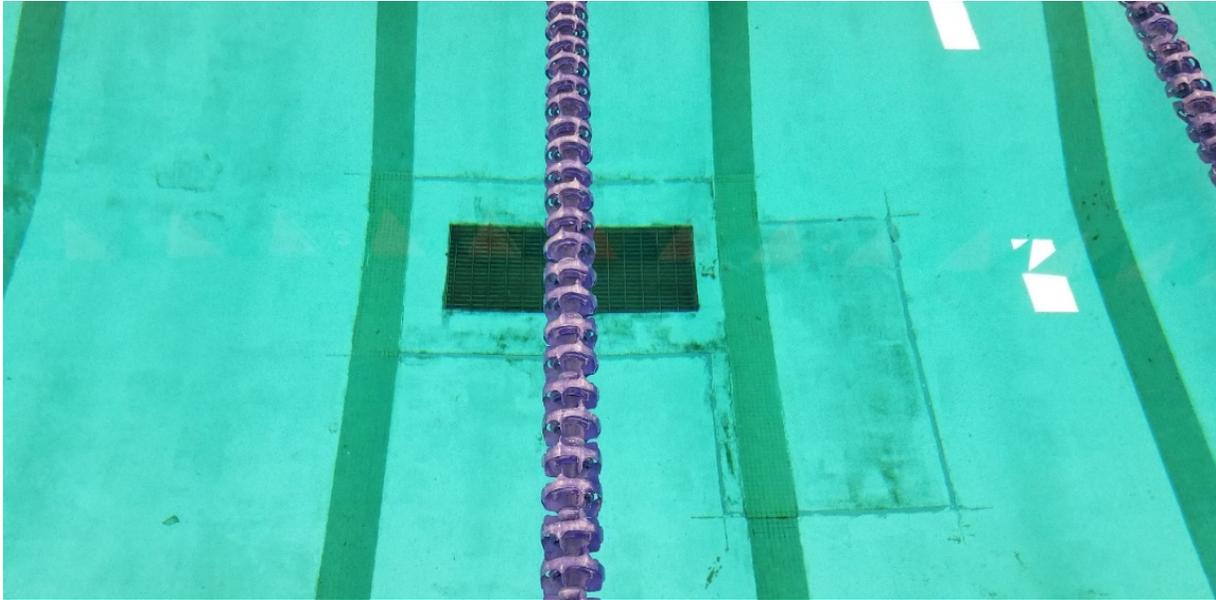
Main drain does not comply with Virginia Graeme Baker Act. Solution is to add two new main drains and piping when deep end is brought into code for diving.

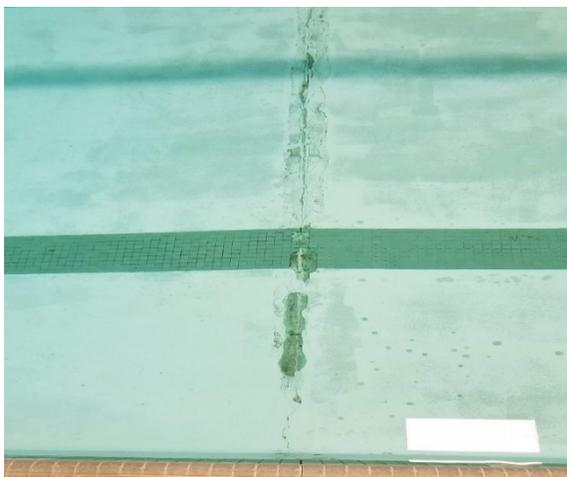
Failed expansion joint to be replaced during deep end reconfiguration and replacement.

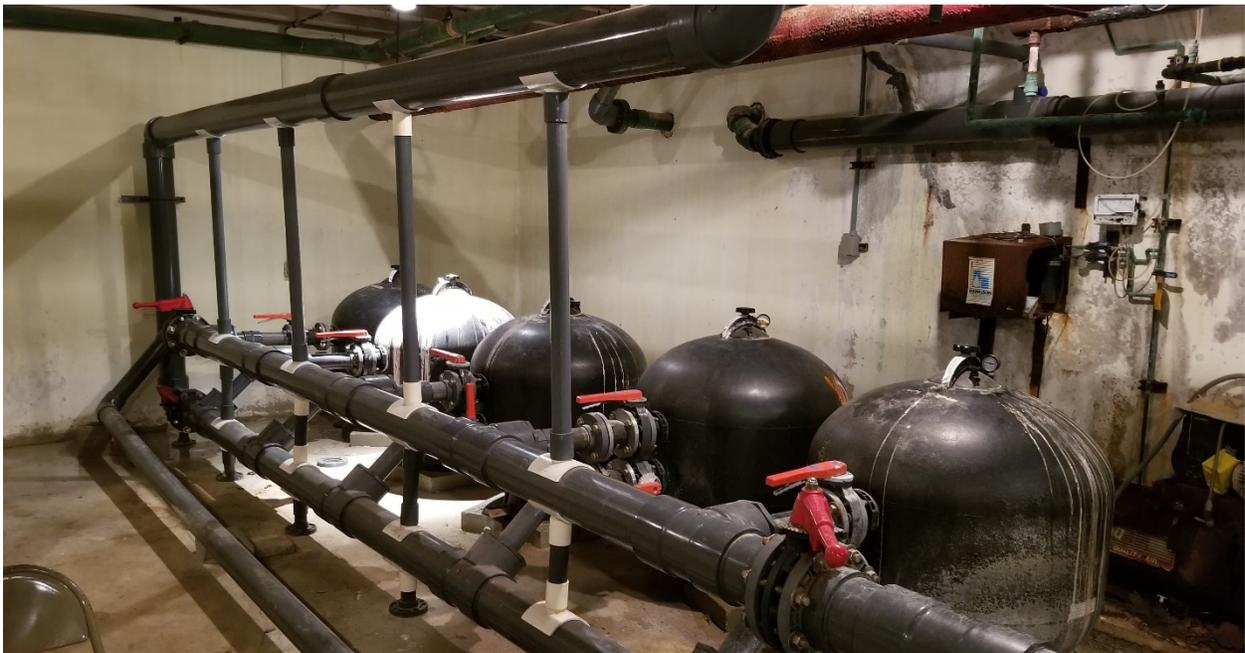
The mechanical room is in the basement below the swimming pool deck. Moisture and humidity must be eliminated from the mechanical room to help reduce corrosion. Anything made of metal located in this room has corroded and should be replaced. Acid has ruined some areas of the concrete floor and should be replaced. All chemicals should be stored in double-walled containers on spill containment pallets. The balance tank does not allow for adequate surge capacity as required by code and should be replaced. Replace existing pumps with new energy-efficient pumps and motors. Remove and replace dilapidated sand filters with a new energy-efficient regenerative media filter system. We recommend installing medium pressure UV systems to remove the combined chlorine from the water and atmosphere. The existing chemical controller needs to be replaced with new systems that communicate with building management systems.

Old sand filter system and piping to be replaced with new energy efficient system to include VFD's, energy efficient pump, medium pressure uv system, chemical automation and regenerative media filter.

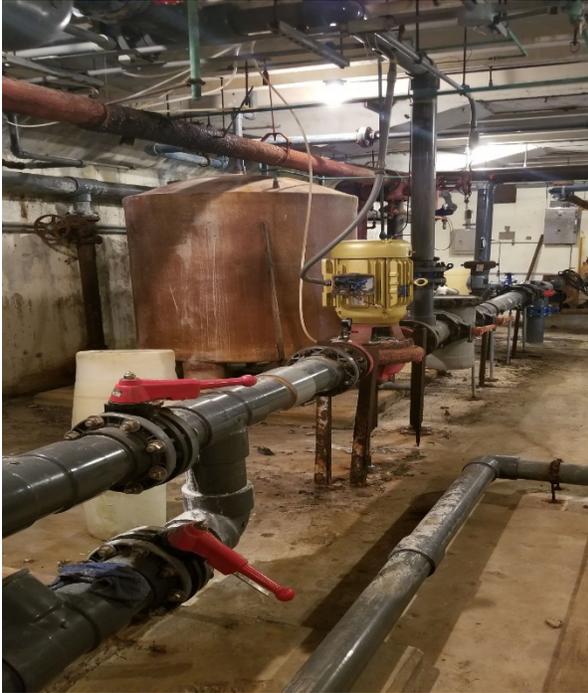
Deck drains and gutter drops are piped to swimming pool balance tank. Code requires deck drains to be routed to sanitary sewer and surge tank sized to provide one gallon of surge capacity per square foot of swimming pool water surface. This piping cross connection will be abated when the swimming pool mechanical systems are replaced, and a new surge tank is installed.

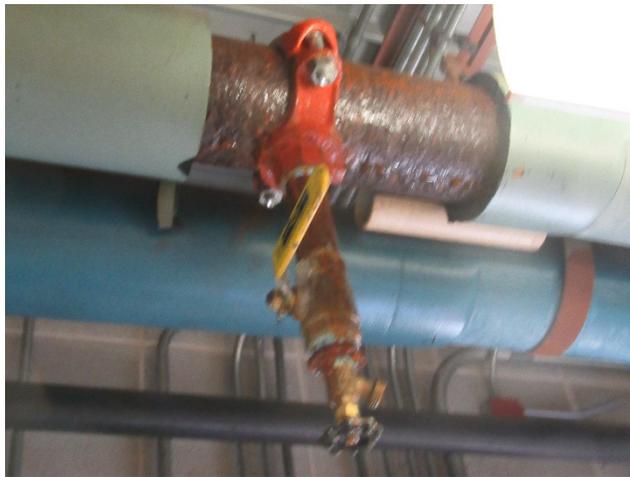
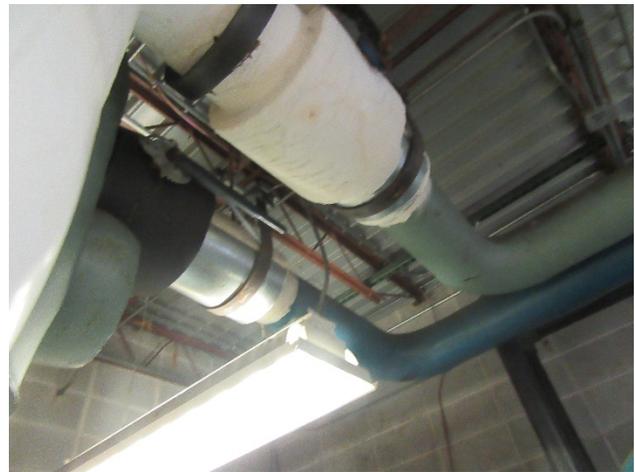
Water is leaking at many of the main chilled water piping couplings. The insulation around the piping is saturated and corroding the piping underneath. The piping in the building is 40+ years old and approaching life expectancy. Furthermore, North Newton Maintenance has shared that several sections of branch piping are also problematic.

Originally Performance Services was planning to remove and replace all couplings. However, after better understanding the concerns from North Newton Schools we are also going to design and price replacing all water piping mains 2 ½" and above. We believe this is the best long-term solution for the issue.

The scope of work will also include the removal of existing ceilings, temporarily hanging lights, and any other devices as required. Demolition of existing chilled water piping, couplings, and insulation. New chilled water piping mains including new couplings and insulation to be installed and reconnected to all branch lines. Existing ceiling, lights, and other devices to be reinstalled.

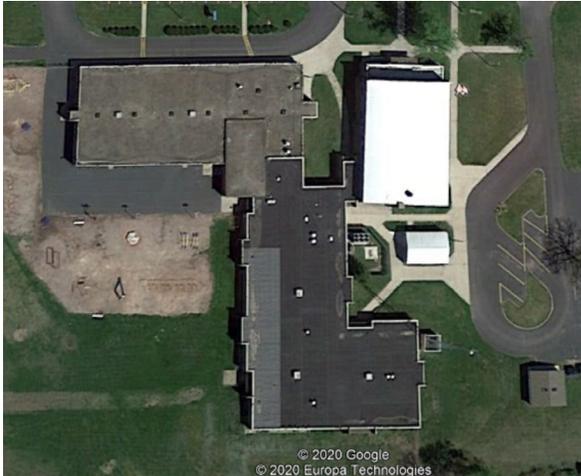
*Lake Village Elementary Existing Roof*

The building is a masonry structure with slight structurally sloped roofs over the main building and a barrel roof over the gymnasium. The building consists of three types of roof systems on the roof areas; a TPO membrane system approximately 2 years old (approximately 7,800 square feet), an Adhered EPDM membrane system of unknown age (approximately 20,000 square feet), and an Aggregate Ballasted EPDM membrane system of unknown age (approximately 16,250 square feet). There are past and current leaks reported at the time of our site visit throughout the school.

The Adhered EPDM roof system deficiencies include, but are not limited to, membrane wrinkles, membrane flashing wrinkles, membrane flashing tenting/bridging, previous membrane repairs, and previous membrane flashing repairs. The Aggregate Ballasted EPDM roof system deficiencies include, but are not limited to, open membrane seams, open membrane flashing seams, membrane wrinkles, membrane flashing blisters, membrane flashing tenting/bridging, previous membrane repairs, previous membrane flashing repairs, displaced aggregate, rusting metal flashings, poor detail heights, obsolete mechanical curbs, vegetation, and poor pipe supports.

Based on the condition of the installed aggregate ballasted EPDM roof system that appears to have passed its intended design life, the reported deficiencies, amount of current and past leakage, repairs to the roof systems, repairs to the interior, visual investigation, and information provided by building personnel, the existing roof system is considered to be in poor condition. Roof replacement should be considered within one year.

The new roof system would consist of a new Adhered EPDM Roof System over a 25 R-value insulation system on the slight structurally sloped roofs. Added insulation crickets/saddles and drain sumps will be installed, as necessary. New associated sheet metal flashings will be included with the project.

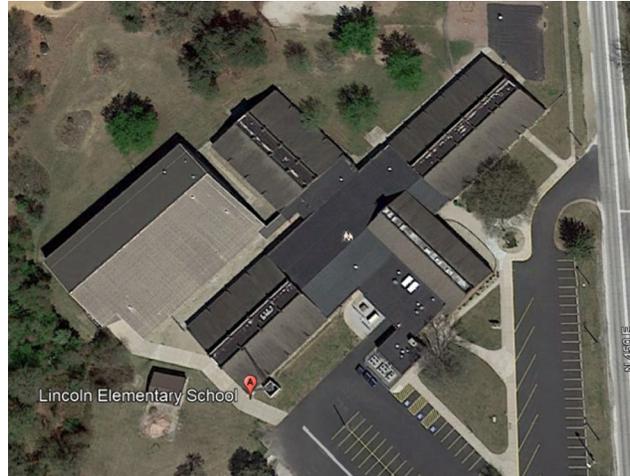
*Lincoln Elementary Existing Roof*

The building consists of four types of roof systems on the roof areas; an Adhered EPDM membrane system approximately 9 years old (approximately 21,500 square feet), a Metal roof system of unknown age (approximately 31,300 square feet), a Modified Built-up roof system of unknown age (approximately 7,750 square feet), and a Shingle roof system of unknown age (approximately 33,700 square feet).

The Adhered EPDM roof system deficiencies include, but are not limited to, membrane wrinkles, membrane flashing wrinkles, membrane flashing tenting/bridging, previous membrane repairs, and previous membrane flashing repairs. The Metal roof system deficiencies include, but are not limited to, dents in the sheet metal, exposed fasteners, backing out fasteners, rusting metal, damaged snow/ice guard fence, previous repairs, and lack of a proper drainage system. The Modified Built-up roof system deficiencies include, but are not limited to, poorly attached membrane, membrane blisters, membrane wrinkles, membrane flashing blisters, membrane flashing wrinkles, open membrane/membrane flashing seams, previous membrane repairs, previous membrane flashing repairs, and ponding. The Shingle roof system deficiencies include, but are not limited to, poor details and granule loss. The mechanical screen wall however has dislodged/missing shingles, exposed fasteners due to the missing shingles, and poor detail installation.

Based on the condition of the installed Modified Built-up roof system, that appears to have passed its intended design life, the reported deficiencies, amount of current and past leakage, repairs to the roof systems, repairs to the interior, visual investigation, and information provided by building personnel, the existing roof system is considered to be in very poor condition. Roof replacement should be considered within one year.

The new roof system would consist of a new Adhered EPDM Roof System over a 25 R-value insulation system on the slight structurally sloped roofs. Added insulation crickets/saddles and drain sumps will be installed, as necessary. New associated sheet metal flashings will be included with the project.
