## Project Understanding

## High School Pool Renovation

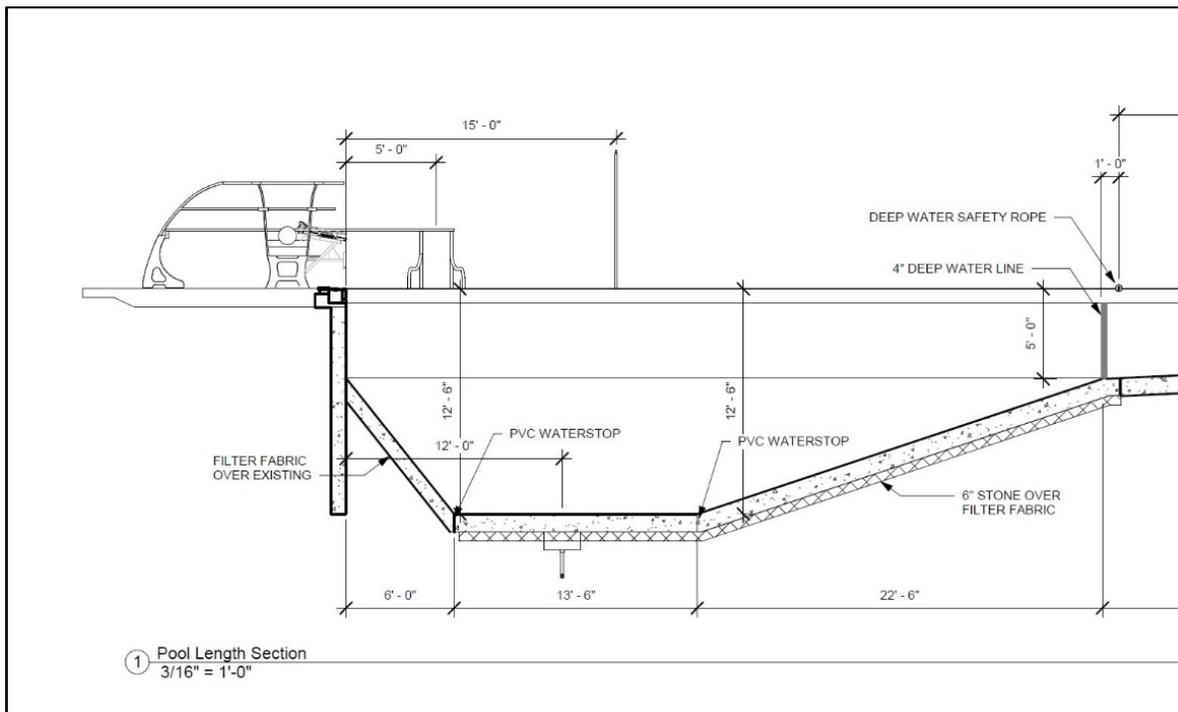
The swimming pool is used for competition and recreational swimming. It is classified as a Type “A” structure by the present Indiana Swimming Pool Code definition. The present circulation (turnover) rate of the pools could not be determined. It appears that the systems have been sized for a 6-hour turnover rate. The concrete walls and floor observed throughout the structure appear to be in generally good condition with a limited number of expansion cracks. There was no evidence of concrete “spalling” or differential surface cracks, which would indicate a weakness of the concrete. The pool floor expansion joint has failed and must be replaced. The original steel piping system is failing and must be replaced with schedule 80 PVC piping. The rollout gutter system is a concrete gutter. The gutter system is not rim flowing around the perimeter of the pool. With the condition of the existing piping, we would recommend removing and replacing the gutter system with a stainless-steel deck level gutter with an integral return system and deck drain.

Deck drains and gutter drops are piped to swimming pool balance tank. Code requires deck drains to be routed to sanitary sewer and surge tank sized to provide one gallon of surge capacity per square foot of swimming pool water surface. This piping cross connection will be abated when the swimming pool mechanical systems are replaced, and a new surge tank is installed.

The proposed solution is for deep end replacement, main drain replacement, and expansion joint replacement. A new deck level stainless steel gutter system with slightly sloped parallel grating, integral deck drains and pressure return tube will be installed around the entire perimeter of the pool. The water surface agitation system will also be provided which will provide a stream of water under the diving board improving visibility of the water for the divers along with a new 1M Duraflex dive stand and 16' maxi "B" board. Single post starting blocks will be provided which also are equipped with angled foot wedge and handle. The pool will also be equipped with appropriate deck equipment including lifeguard chairs, grab rails, backstroke stanchion posts, lane lines, and an ADA lift.
